## **Condition Assessment of Ancient Architectural Monuments in the Pergamon Museum – The Combined Application of NDT-Methods for Structural Investigations**

In this paper the possibilities of the combined application of nondestructive testing (NDT) methods for structural investigation of ancient architectural monuments is presented using the example of the columnar portal of the holy hall at the market gate of Priene in the Pergamon Museum, Berlin. Due to missing documentation and in the context of a structural condition assessment, it was necessary to determine the rear anchorage of the entablature and to verify the structural bond between the artificial stone and the original material in the architrave of the monument. The combined use of radar and videoscapy proved very efficient in conjunction with the determination of the type and position of the metal components of the rear anchorage of the entablature. The structural investigation of the architrave was accomplished by radar and radiography. The radar method was utilized to determine the overall position of the metal special fittings. Additional investigations by radiography using a new generation of digital imaging plates

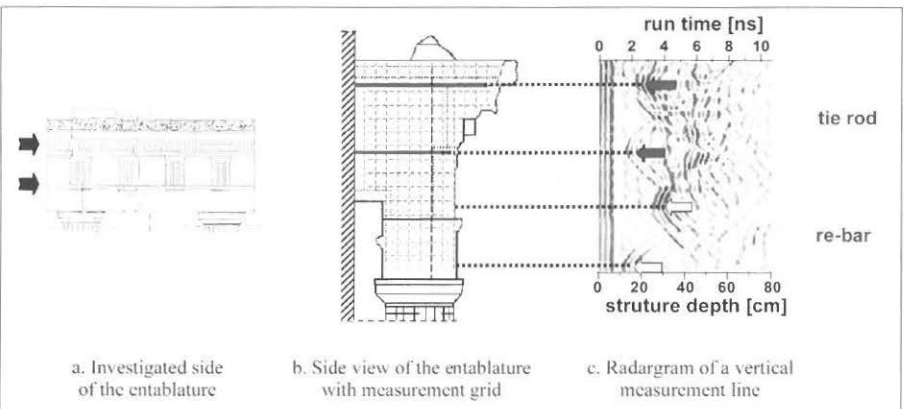
Figure 7 shows an example of a radargram, obtained by moving the radar antenna along a vertical line of the measuring grid on the side elevation of the entablature. The two upper diffractions were caused by horizontal running tie rods and the lower by horizontal running reinforcing bars.

Figure 7. Selected results of the radar investigations with a 1.5 GHz-antenna pair.

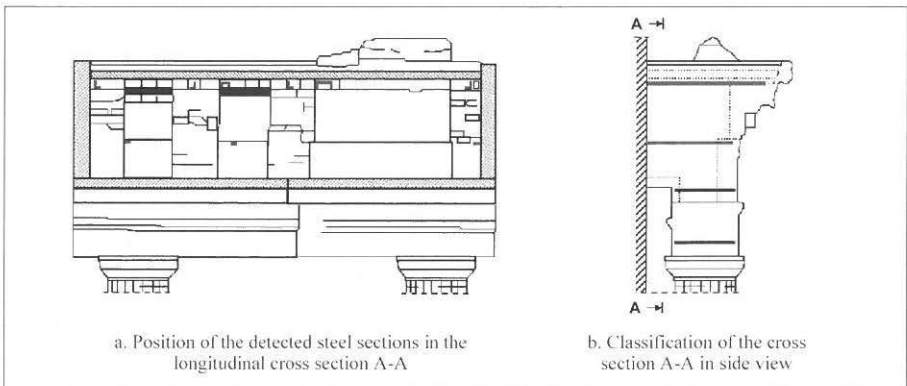
The videoscapy permitted an exact verification of the cross sectional shape of all tie rods. Altogether steel profiles with L- and U-shapes as well as flat steel bars were used. (Fig. 8).

Figure 8. Result of the videoscopic investigations.

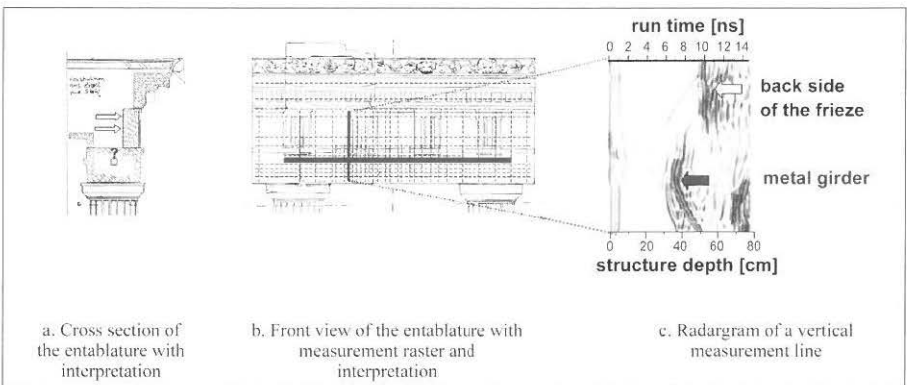
Figure 9 illustrates an exemplary radargram with two different diffractions. The radargram has been measured by moving the antenna along a vertical line of the grid applied to the front of the entablature. The upper diffraction suggests a large surface parallel reflector (back wall of the frieze plate) and the lower a geometrically clearly smaller reflector (metal reinforcing bar). Since all the radargrams along the vertical grid lines on the front of the entablature differ only slightly from each other (with the exception of the boundary region), it can be concluded that the metal profile must run continuously through the architrave. This is also confirmed by the radargrams from the underside of the architrave (Fig. 10). Here metal dowels can be recognized in the area between original marble and artificial stone. However, their exact position, shape and dimensions cannot be determined by radar only. The same applies to the shape

Figure 9. Selected result of the radar investigations at the front of the entablature with the 1.5 GHz-antenna pair.

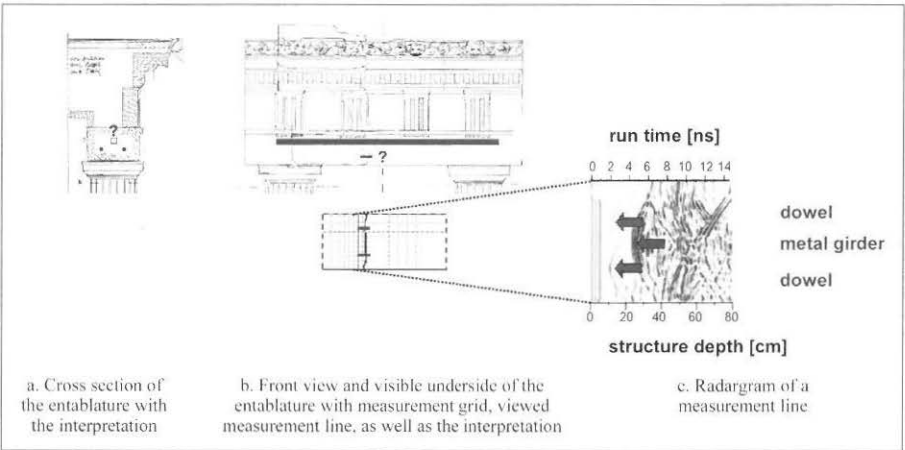
**Figure 10.** Selected result of the radar investigations at the underside of the architrave with the 1.5 GHz antenna pair.

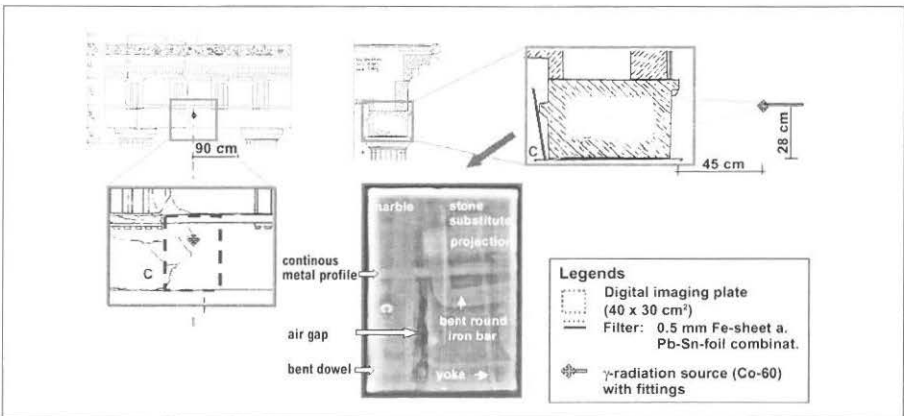
These are described by the examples provided by Figures 11 and 12. In the grayscale images bright areas indicate high material density and/or greater thickness of a structural element. Dark areas represent the opposite. The grayscale image of Figure 11, which was obtained by the external arrangement of the radiation source, illustrates the presence of a gap between the original marble and the artificial stone. In addition, parts of the metal bars and girder passing through the architrave could clearly be recognized. It was evident that the dowels extended only into the original marble and not into the artificial stone. This led to the important conclusion that the dowels do not tie the marble to the artificial stone.

**Figure 11.** Result of the radiography on a selected measurement point with external positioning of the radiation source.

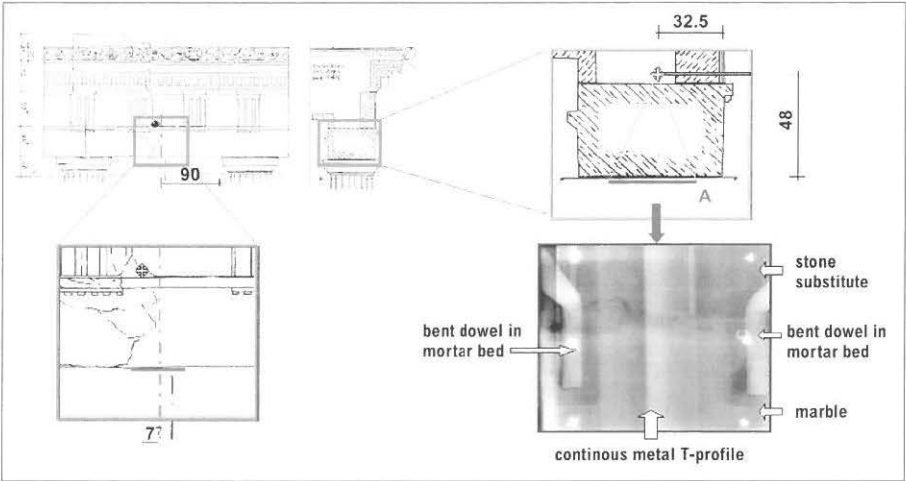
The grayscale image of Figure 12 was acquired by positioning the radiation source in the entablature internally. It shows the exact position and shape of the dowel in the interface of marble and artificial stone: the dowels are embedded into the marble with mortar and are bent outward, not locking into the artificial stone. The geometry of the measurement arrangement and the resulting radiograms also allowed for detection of a T-shaped profile for the girder, which runs through the architrave.

**Figure 12.** Result of the radiography on a selected measurement point with internal positioning of the radiation source.

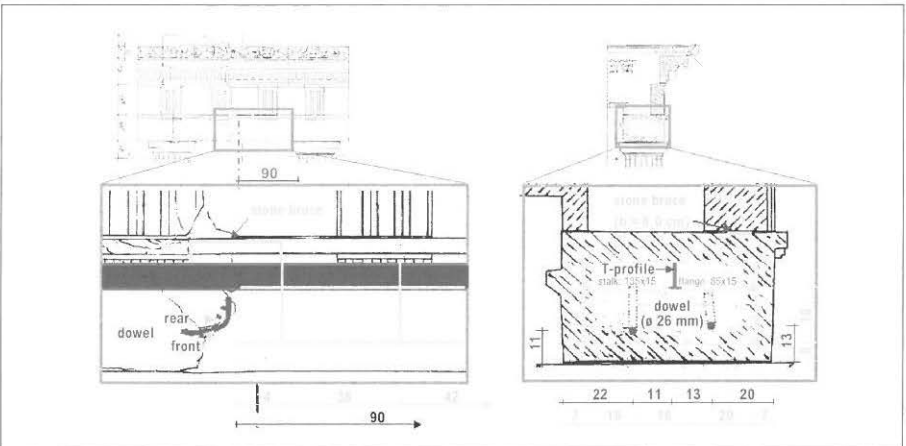
Figure 13 shows in summary the exact spatial position of all non-destructively determined reinforcements in the architrave with their shapes and dimensions.

**Figure 13.** Reconstructed position of all metal reinforcement in the architrave as a summary of the application of non-destructive testing methods.

- Type and position of the steel sections for the rear anchorage of the sima.
- Confirmation of the load bearing capacity of the architrave, which is established primarily by a continuous T-shaped steel girder (dimensions were determined).
- The presence of an air gap in the architrave at the interface of marble and artificial stone.
- No actual connection between the original marble and the artificial stone, since the dowels protruding from the marble were bent upwards into the gap.
