Berliner Beiträge zur Archäometrie	Band 21	Seite 13-22	2008
------------------------------------	---------	-------------	------

Condition Assessment of Ancient Architectural Monuments in the Pergamon Museum – Investigation of Paint and Stone Substitute Material by Micro Analytical Methods

Federal Institute for Materials Research and Testing (BAM), Germany

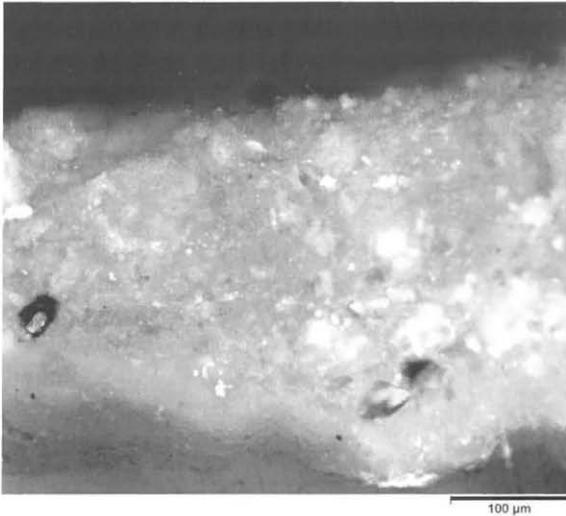
Figure 3. Original paint sample from the Athena sanctuary of Pergamon, containing red ochre as a pigment (photo micrograph, reflected light, crossed polars).

On parts of the entrance hall of the Athena sanctuary from Pergamon fragments of a red paint were found. The paint consisted mostly of red ochre, which was probably associated with an organic binder. However, traces of organic components could not be found and might have been transformed by microorganisms. The photo micrograph in Figure 3 shows a dense texture of the red ochre. The composition detected by SEM and XRD analysis was similar to the one stated by Scheweppe (1993). It contained clay

minerals, hematite, calcite and few amounts of feldspars. The paint showed usually an intergrowth with gypsum, which was enriched at the interface to the substrate. This indicates that the original marble was transformed on the surface into gypsum. Part of the gypsum grew into the paint layer and formed little nests and agglomerations.

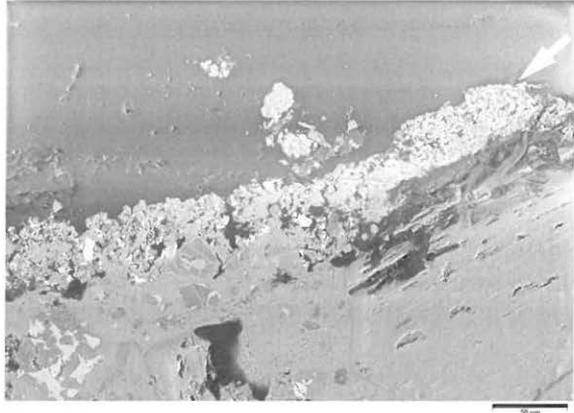
Figure 5. Modern paint (arrow) with a silicate binder and lithopone white and umbra as pigments (SEM image, backscatter mode).

Additionally fillers of lime and gypsum were used. Lithopone white is a mixture of barium sulfate and zinc sulfide. Both phases are usually precipitated together in order to form a white pigment. To give the paint a more brownish appearance umbra, a mixture of manganese and iron oxides, was added. Sometimes nodules of amorphous SiO_2 could be observed. The actual paint was applied as a thin layer of 50 μm in average mostly on the stone substitute (Fig. 5). Only in few cases it could be observed on marble adjacent to the stone substitute.
