## **Condition Assessment of Ancient Architectural Monuments in the Pergamon Museum – The Combined Application of NDT-Methods for Structural Investigations**

In this paper the possibilities of the combined application of nondestructive testing (NDT) methods for structural investigation of ancient architectural monuments is presented using the example of the columnar portal of the holy hall at the market gate of Priene in the Pergamon Museum, Berlin. Due to missing documentation and in the context of a structural condition assessment, it was necessary to determine the rear anchorage of the entablature and to verify the structural bond between the artificial stone and the original material in the architrave of the monument. The combined use of radar and videoscapy proved very efficient in conjunction with the determination of the type and position of the metal components of the rear anchorage of the entablature. The structural investigation of the architrave was accomplished by radar and radiography. The radar method was utilized to determine the overall position of the metal special fittings. Additional investigations by radiography using a new generation of digital imaging plates

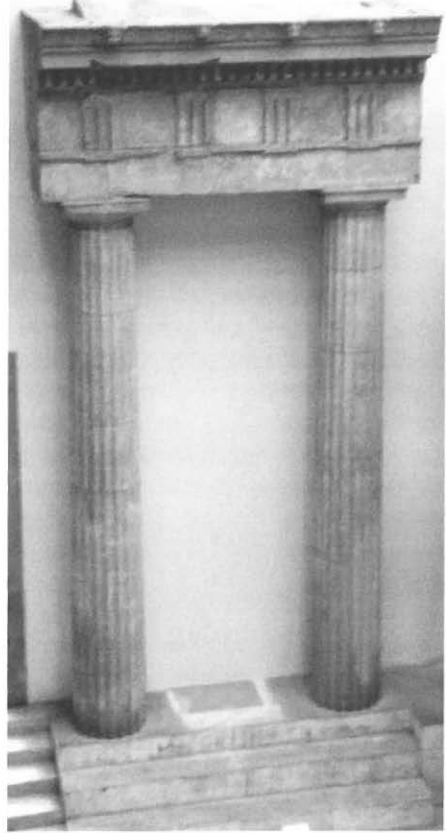
The investigation focused on a reconstructed portion of the holy hall at the market gate of Priene. This acted as a pilot study to prove the suitability of NDT-methods for this type of construction. The main task focused on the entablature, which is primarily reconstructed in reinforced artificial stone (Fig. 1).

**Figure 1.** View of the columnar portal of the holy hall of the market gate of Priene.

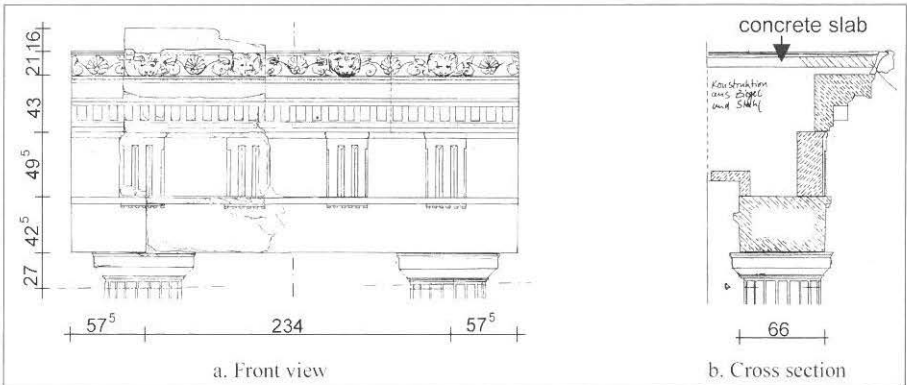
Interconnected cavities and voids behind the tryglyph frieze, the dentil course and the gaison allowed the use of videoscopy for analyzing the rear anchorage of the sima (Fig. 4).

Figure 4. Detail design of the entablature of the columnar portal.

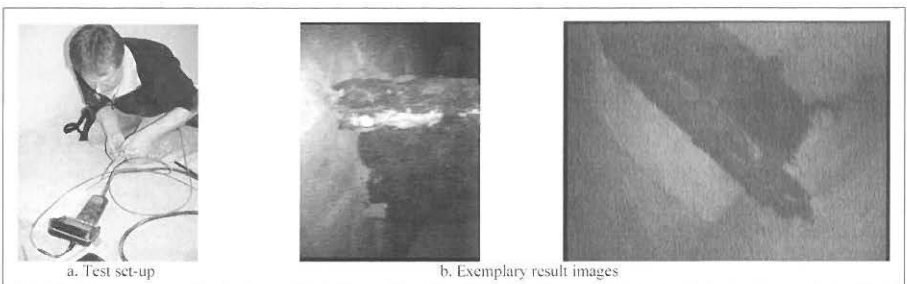
The cavities were accessed by drilling a small hole into the concrete slab covering the entablature. Figure 5 provides a visual impression of the videoscopic observation on site.

Figure 5. Realization of the videoscopic observation of the anchorage at the cantilevered sima.
